# ACCESS TO REMOTE COCONUT AREAS

By R. B. RODRIGO,  
*Senior Field Assistant to Soil Chemist.*

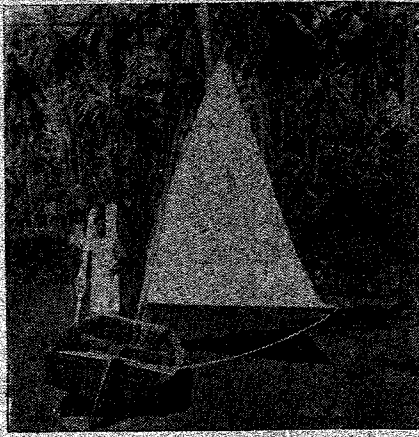
The Boat.

The boat is 10 ft. 6 ins. long and 3 ft. 6 ins. broad. It is equipped with two oars and has a mast with a small single lug sail. As a rowing boat, it can carry a total load of 770 lbs. (5 passengers) but the best burden for sailing is 280 lbs. (2 passengers).

The sides, keel, battens, and the floor of the boat are of wood; the bottom of the boat is of strong painted canvas which is completely waterproof and leakproof. The only water which can enter the boat is over the sides in rough weather. The makers say that they have a folding boat which has been in regular use for 20 years, without renewing the canvas, but it must be painted once a year and the woodwork too needs to be regularly varnished.
